Bureau of Air Safety Investigation

INVESTIGATION REPORT

9300484

**Mikoyan & Gurevich
MiG 15UTI, VH-LSN
Canberra, ACT
13 March 1993**

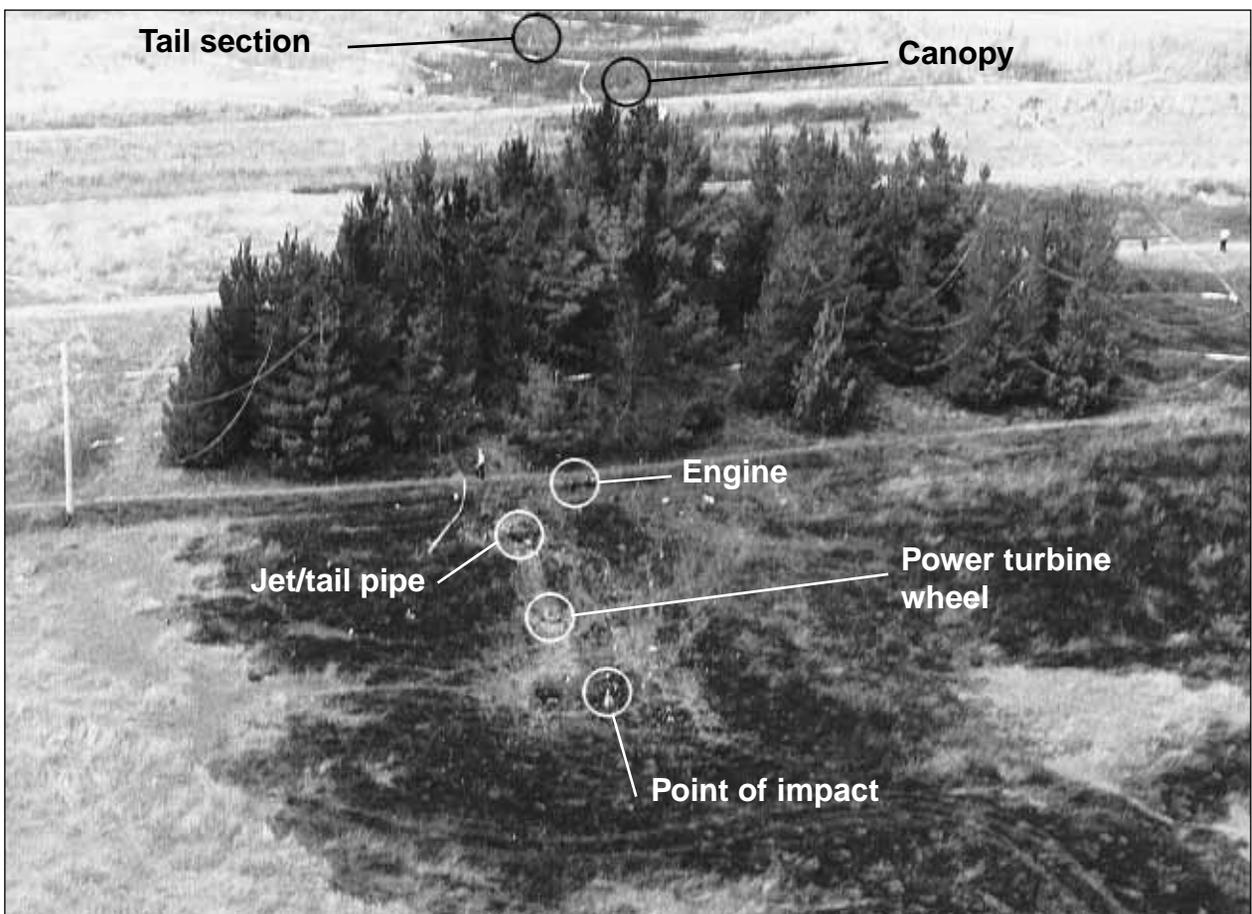
Figure 2. Impact point and major wreckage items of VH-LSN.

The aircraft crash site (figure 2) was located 300 m west and 200 m north of the intersection of the Monaro Highway and Hindmarsh Drive in the suburb of Narrabundah, Canberra. Physical evidence at the site indicated that the aircraft impacted the ground in a near wings-level, 25° nose-down attitude. When the aircraft struck the ground, immediate breakup and disintegration of the structure occurred. Wreckage as shown in figure 2 was scattered over an area about 200 m long in the direction of flight and 100 m wide. The extent of the wreckage and impact area were consistent with the aircraft impacting the ground at a speed in excess of 150 kts.

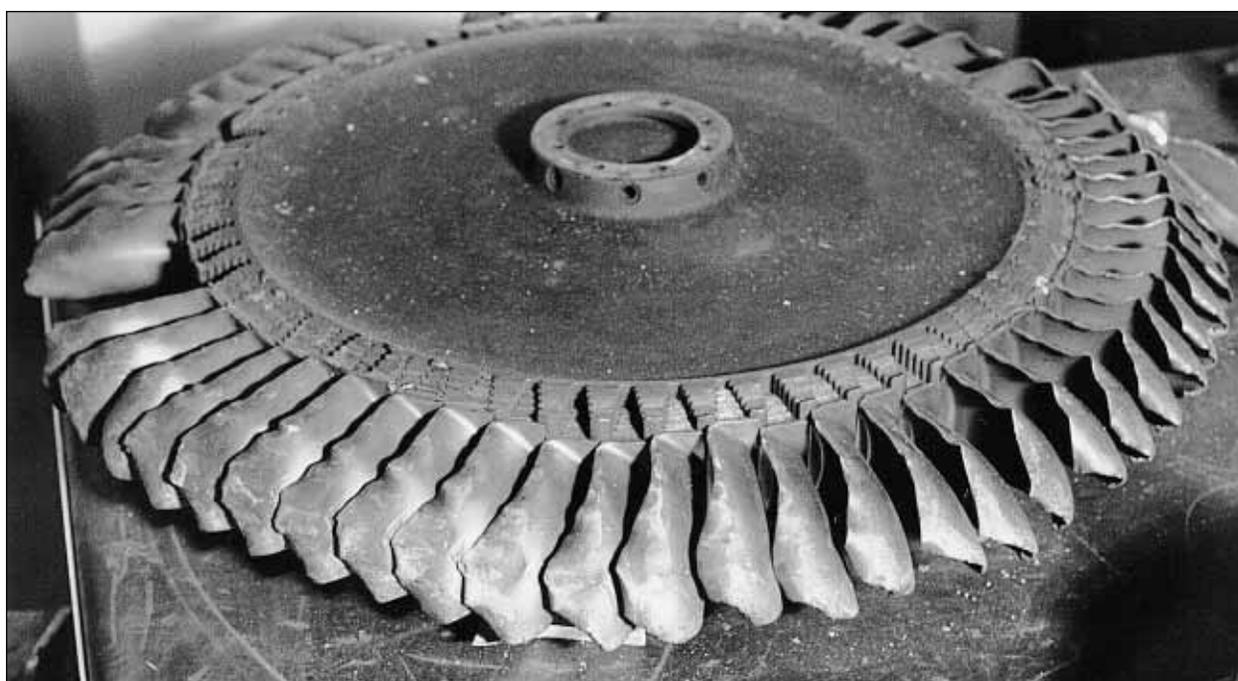
The turbine wheel (figure 3) was liberated by failure of the drive shaft coupling attachment bolts and departed the airframe vertically with sufficient energy to cut a slot through the turbine case and jet-pipe entry. It came to rest approximately 50 m from the initial impact point along the direction of flight. All the turbine blades remained in the turbine wheel and there was no evidence of blade dislodgment.

Figure 3. Engine turbine wheel showing damage to all blades.
Note: Several blades had been removed for examination.

The turbine blades were subjected to detailed metallurgical examination. This examination concluded that the sample turbine blades had failed through creep rupture. Failure resulted in the loss of 25–30 mm from each tip of the blades examined.

Creep is a phenomenon dependent upon strain, temperature and time. The metallurgical examination conducted found no evidence to suggest the blades experienced excessive temperature. Also, no evidence existed to suggest that the engine was subjected to excessive RPM (i.e. strain). Hence, the primary reason for the failure of the turbine blades examined was the length of their time in service.

The metallurgical analysis of the turbine blades conducted by the CASA Materials Evaluation Facility concluded that they had failed through creep rupture. Failure resulted in the loss of 25–30 mm from each blade tip. The damage was consistent across the nine sample blades available for examination.

The Materials Evaluation Facility report stated that the creep phenomenon is dependent upon three variables—temperature, strain and time. This report stated there was no evidence that these blades experienced excessive temperature during their operating life. Witness comments have highlighted instances where the jet pipe temperature apparently exceeded the specified limits. As metallurgical examination failed to identify crystalline structure changes due to excessive temperature, the instances of over-temperature were obviously very minor, or were gauge problems as suggested by the pilot. Notwithstanding this uncertainty, established turbine blade theory states that the operating life of a blade is reduced when it experiences temperatures in excess of the specified maximum value. Hence, if these turbine blades experienced temperatures in excess of the maximum specified limits, they would have a reduced operating life.

The post-accident review of both fuel pump over-speed governors found no evidence of malfunctioning. Therefore, excessive strain, caused by out-of-tolerance rotor RPM, should not have contributed to the observed blade creep.

With temperature and strain removed as contributing factors to the creep failure of these blades, their operating life becomes the prime consideration.

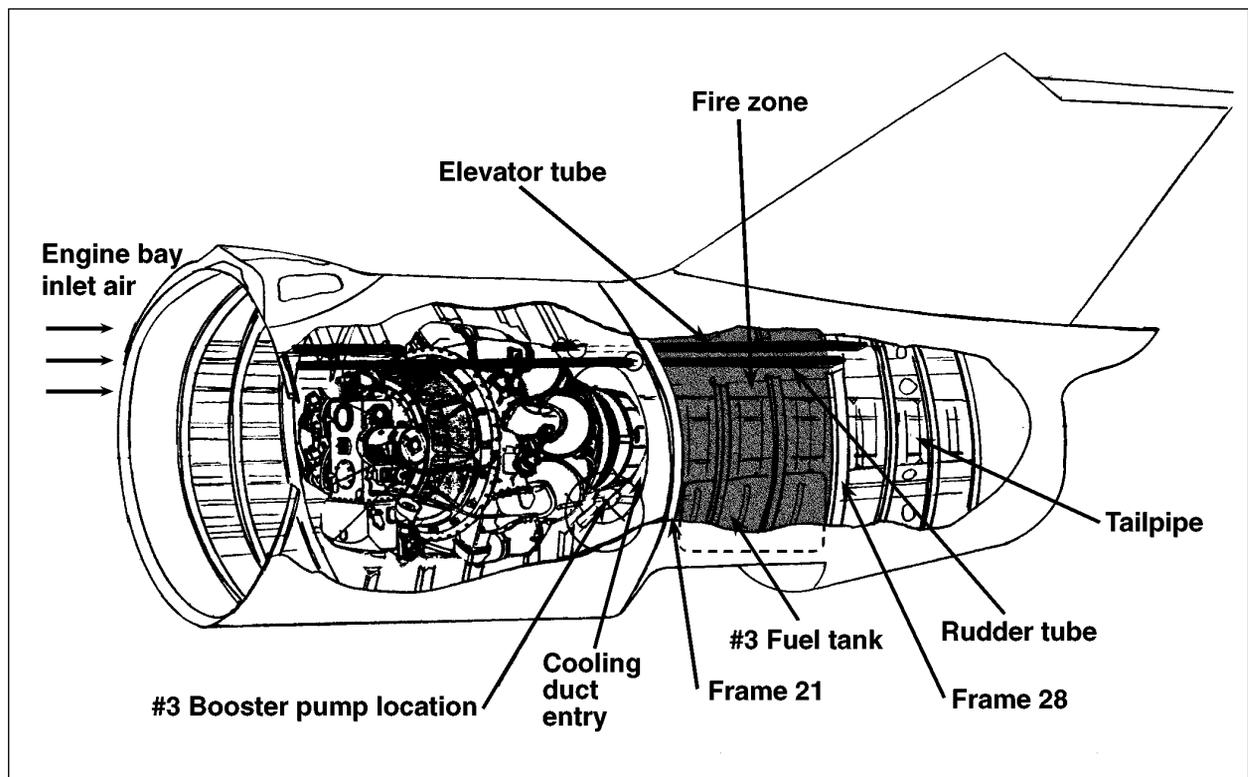
The number three fuel tank (figure 4) comprised two separate half tanks connected with 'TEE' plumbing and had a fuel capacity of 166 L. The tanks were manufactured from 2024/3000-series aluminium. A portion of the rear section of the right number three fuel tank was recovered. All right tank fracture surfaces were considered to be cold fractures. The forward section of the left number three tank was also recovered. Hot internal impact fractures were evident and it was estimated that at impact the tank metal temperature was at about 450°C. Some rivet heads in the tank structure showed signs of hot fracture but it could not be determined if the fractures occurred before or after impact.

The complete run of rudder control tubes and elevator control tube was not recovered. Some of the tube pieces may have been destroyed in the areas of intense ground fire. The elevator tube which runs through the aft cockpit in the area of frame 13 was located and the fracture surfaces showed signs of overload failure. The tube was found outside the ground fire area and was not burnt. The forward rudder tube remained in frame 13 and was burnt. Portions of the airframe skin from both sides of frame 13 were located in the ground fire area.

A mounting bracket with bell crank arms and the control tube ends was located clear of the ground fire area. This was identified as the rudder control. It had been positioned in the aircraft immediately aft of frame 21. The ends of the tubes were burnt. Molten splatter identified as 2024 aluminium was found in an axial direction inside the tube.

Both tubes in the fin base were fractured and remained with the fin when it separated from the aircraft at impact. SEM analysis of the elevator and rudder tube microstructures at the fin base showed that melting and resolidifying had occurred along the grain boundaries with attendant loss of bond strength within the metal structures. The elevator trim screw jack setting was measured and it is estimated that the trim was set for a speed of about 280 kts which is consistent with the speed the aircraft would reach shortly after the pilot completed his climbing turn.

Figure 4. Fuselage showing approximate locations of controls, rear fuel systems, engine and tail pipe.

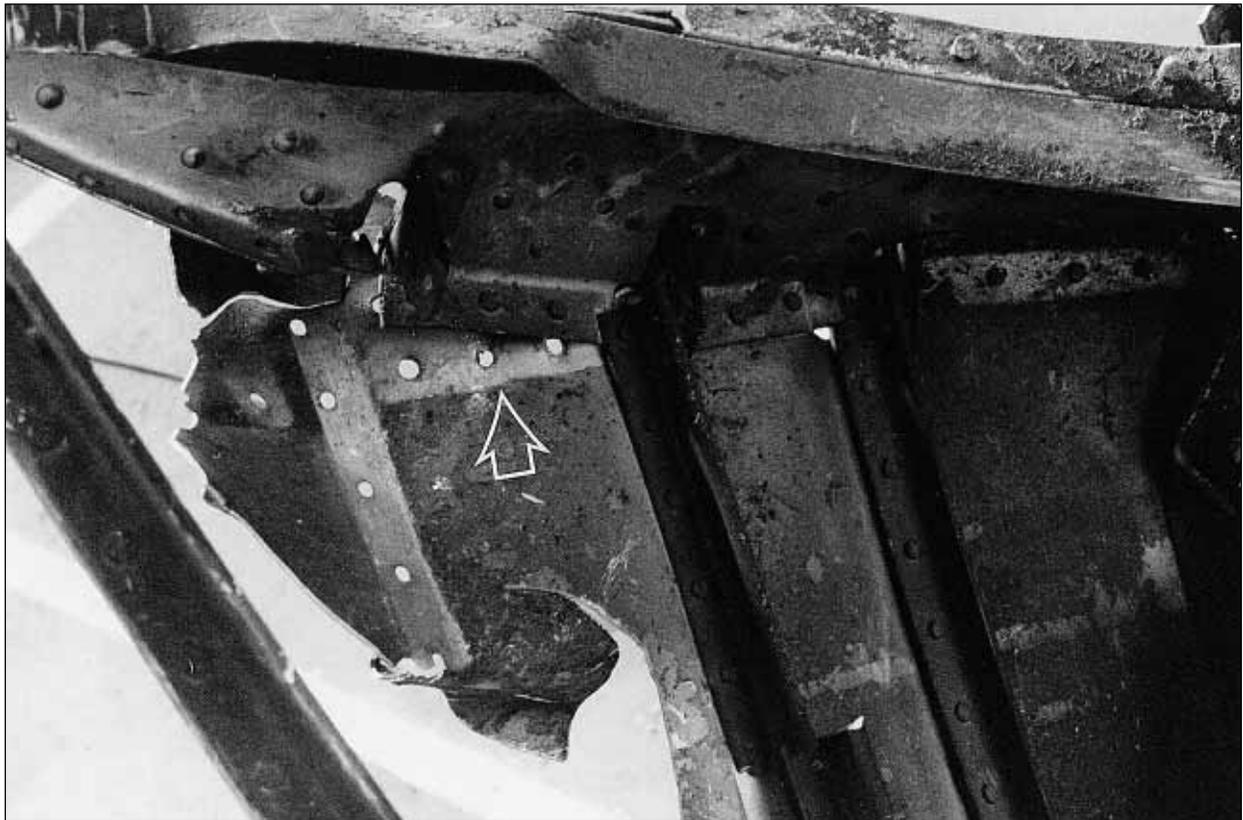
- Deposits of combustion products were found throughout the number three fuel tank bay.
- In the area between frames 21 and 24, soot shadows were left on the inner skin where stringers and frames had pulled out during impact (figure 5).

- A clearly defined burning of red painted skin was found aft of frame 21 with unburnt silver painted skin immediately forward of frame 21. Evidence of ground fire was apparent about 20 cm forward of frame 21.

- The fuselage cooling duct was burnt away between frames 21 through 24 and aft. Some of the duct material remained from frames 24 to 28 forward of the tail cone area with the forward facing fractures having either melted ends or hot shear fractures from impact disruption.

Figure 5. Exposed internal skin showing airborne fire sooting. Areas free of soot (arrow) indicate where overlapping metal was pulled apart at impact.

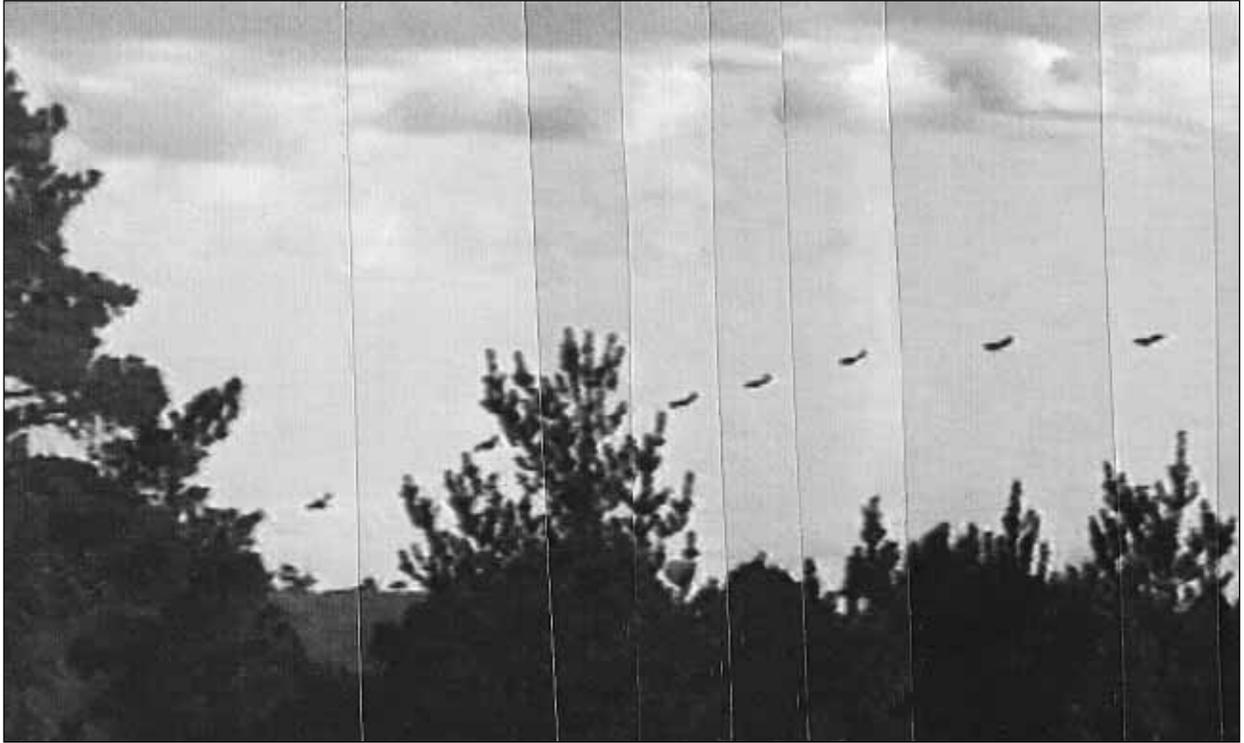
Figure 6. Final flight path of VH-LSN (video tape).

A home video was taken of the aircraft during the start, taxi to the runway, the takeoff and climb, portions of the flight, and the descent of the aircraft just prior to impacting the ground. It showed the aircraft taxiing onto the runway and commencing an immediate takeoff. The acceleration appeared uniform. As the aircraft lifted off it was levelled at about 15 ft and the landing gear was raised. The aircraft then commenced a smooth, coordinated climb and left turn to an altitude of about 1,200 ft AGL. The aircraft then continued in a gradual left turn, away from the airfield. A puff of dark smoke was observed behind the tail pipe shortly after the aircraft completed its climbing turn. As the flight progressed the height appeared to remain

constant. As the aircraft reached a downwind position, a plume was visible behind it; however, it could not be determined if the plume was smoke or some other form of vapour. The aircraft then gradually lost height and turned left. As the aircraft lost height it returned to a wings-level attitude and appeared to slow. The pitch attitude then changed from a level or slight nose-up attitude to about 30–40° nose-down (figure 6). When the nose initially dropped, the right wing dropped a few degrees and then immediately returned to a wings-level attitude. The aircraft then descended out of sight behind some trees.
