Bureau of Air Safety Investigation

INVESTIGATION REPORT

9300484

**Mikoyan & Gurevich
MiG 15UTI, VH-LSN
Canberra, ACT
13 March 1993**

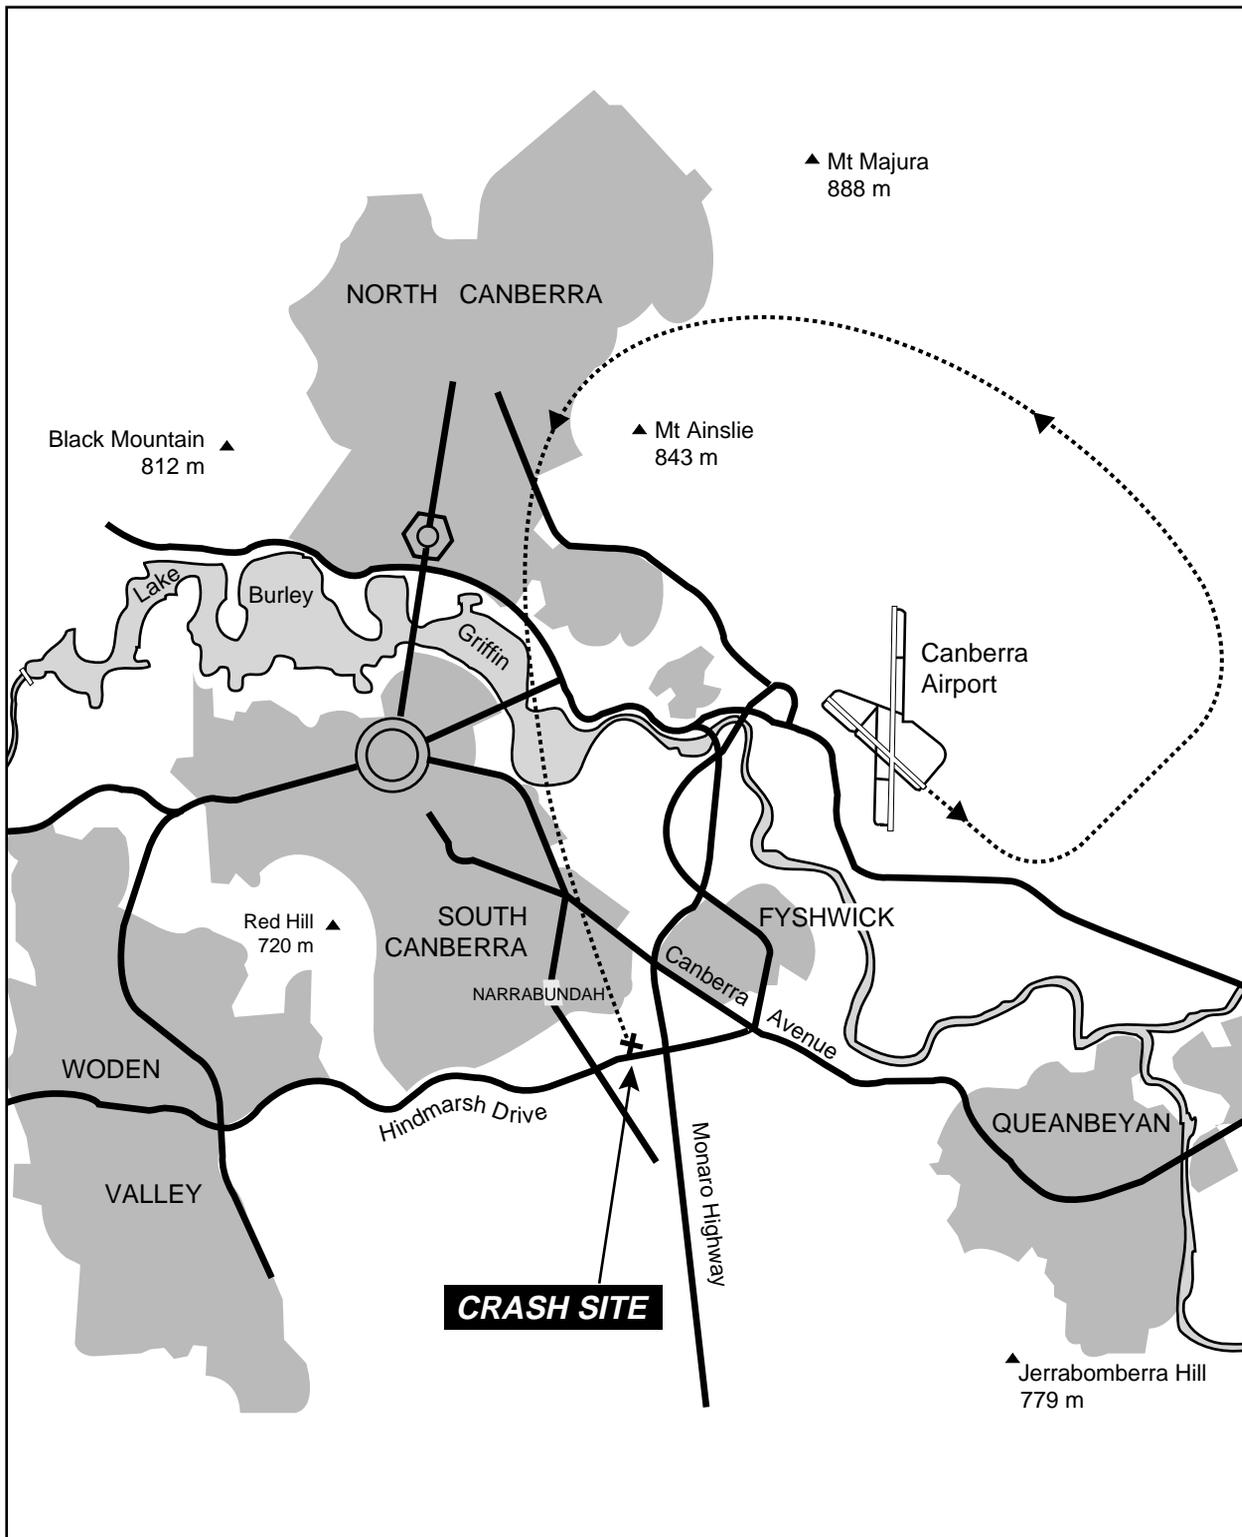
Figure 1. Approximate flight path and impact location of VH-LSN

A diagram depicting the approximate flight path and impact location of VH-LSN is at figure 1.
